Integrating GIS and Revit for Waterproofing Solutions in Historical Pitched Roof Buildings

Vikrant Sawant¹, Dr. Sumedh Mhaske²

¹Student, M. Tech Construction Management, Civil and Environmental Engineering Department, Veermata Jijabai Technological Institute (VJTI), Matunga, Mumbai, 400019, India

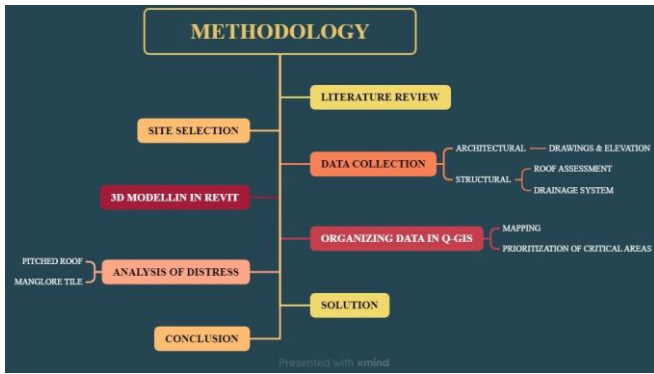
Figure 1: Methodology

This research followed a multi-stage approach to waterproof a historical structure. First, a detailed literature review explored the historical significance of structures, the typical building materials and construction methods used in its period, maintenance plans adopted for historical structures, different roofing material used. This understanding helped identify effective waterproofing solutions that wouldn't compromise the structure's historical integrity.

Site selection was crucial. Choosing the right historical building set the stage for the entire project, impacting the research process, the depth of findings, and ultimately, the project's success.

Once a suitable site was chosen, data collection began. This included architectural details, structural details (2D drawings), and a structural assessment. The assessment focused on the roof and drainage system to pinpoint any weaknesses that might be causing water leaks.

A 3D model of the structure was then created using Revit software. Any defects identified during the structural assessment were marked on this model to aid communication and collaboration with stakeholders involved in the project's management.

Next, all the collected data was organized within QGIS software. This allowed for the identification of areas with the most significant defects, facilitating targeted resource allocation during the waterproofing process.

With a firm grasp of the pitched roof's condition and the specific type of roofing material (Mangalore tiles), a detailed analysis of potential water leakage points was conducted. Identifying the exact causes of the leaks was essential for formulating the most appropriate waterproofing solution. Finally, with a clear understanding of the structure's vulnerabilities, solutions were developed to stop water ingress and prevent further deterioration of the historical building.

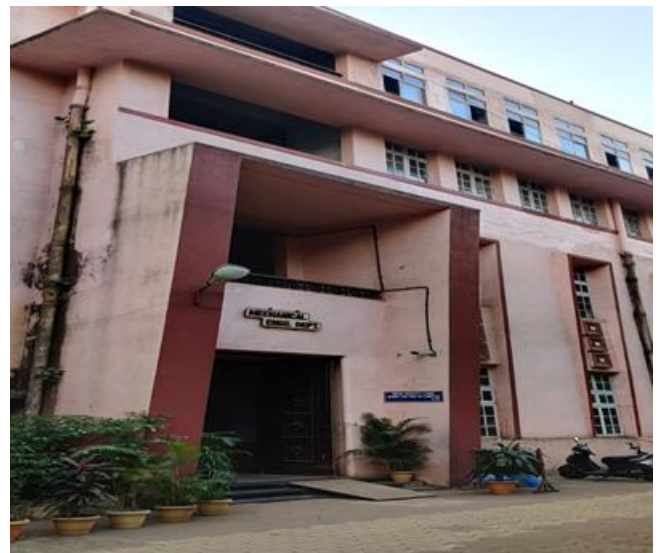
Figure 2: Mechanical Engg. Department building, VJTI

Within the esteemed campus of Veermata Jijabai Technological Institute (VJTI), several historic structures stand as evidence to the institution's rich heritage and architectural significance. Among these, the Mechanical Building stands out for its unique roof design, a combination of pitched and flat roof, reflecting the architectural sensibilities of its period.

Name of Structure & address	VJTI, Mechanical Engineering Department Building, R. Mahajani Marg, Matunga Road, Mumbai -19, Maharashtra, India.
Year of construction	1948-1964
Drawings Available	Yes
Current Use	Institutional Building
Type of structure	RCC
No. of floors for building	G+3
No. of Staircase	3
Floor to floor height	5m

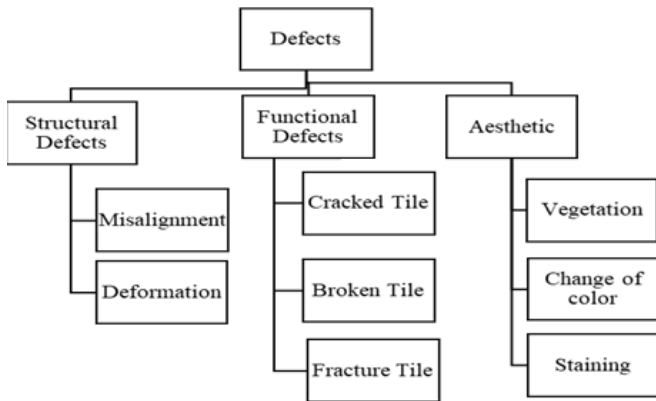
Figure 3: Different defects of pitched roof

To fully identify defects in the historical structure's roof system, an intensive data collection process was undertaken. This involved two key steps: first, a detailed review of any existing 2D architectural drawings to gain information on the roof's geometry, framing system, materials, and drainage. Second, a thorough visual inspection was conducted from both the interior and exterior of the roof.

This inspection precisely documented any signs of deterioration, and subsequently categorizing all observations, a clear picture of the roof's condition was established.

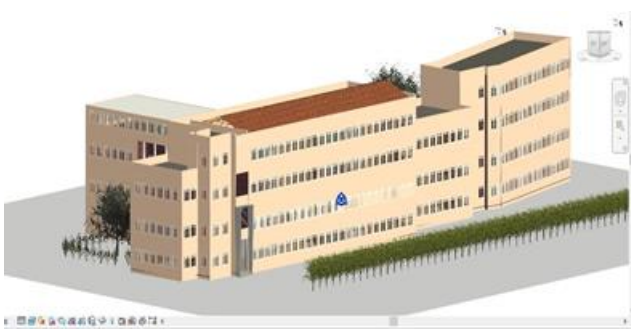
Figure 4: 3D model of mechanical building, VJTI

To further enhance the understanding of the roof system's condition and facilitate communication with stakeholders, a 3D model of the historical structure was precisely crafted using Autodesk Revit software. This digital representation provided a detailed and visually intuitive view of the entire building & roofing system. The identified defects and distresses pinpointed during the structural assessment were then precisely mapped onto the 3D model. By employing a color-coding system, the location, extent, and severity of each issue were clearly differentiated. This visual approach offered a significant advantage over traditional 2D documentation. Stakeholders, including architects, engineers, and restoration specialists, could readily grasp the overall condition of the roof system, enabling more informed decision-making regarding the most appropriate and historically-sensitive waterproofing solutions.

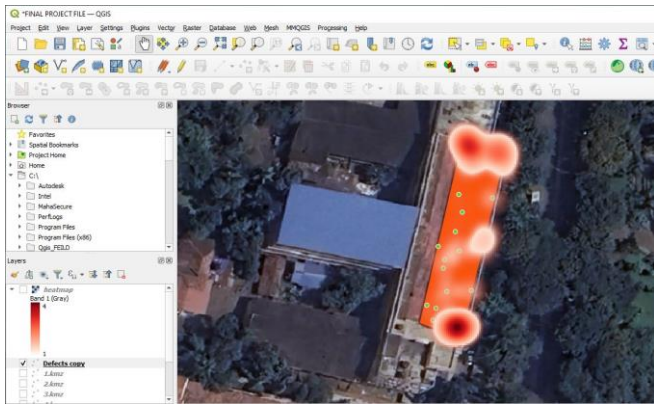
Figure 9: Heat Map of distresses based on level of degradation

Following the creation of a detailed 3D model incorporating distress markings, the identified defects were meticulously organized within a Geographic Information System (GIS) platform, specifically QGIS. Subsequently, the defects were ranked based on their intensity and potential to compromise the structural integrity of the roof. Employing the Kernel Density tool within QGIS, a heat map was generated. This heat map visually represented the concentration of distress, with areas of higher density indicating a greater potential for structural integrity issues. This analysis served two key purposes. Firstly, it helped identify locations where the combined effect of multiple, severe distresses could compromise the integrity of roof. Secondly, the heat map provided insights into potential pathways for water ingress. Areas with a high concentration of distress might be more susceptible to water infiltration, potentially leading to further deterioration.

Degradation Level	Percentage Affected area (Aa)
0	Slightly Visible
1	< 10% Aa
2	10%– 30% Aa
3	30% - 50% Aa
4	>50% Aa

Building upon the analysis conducted within QGIS, the next stage of the research focused on a detailed examination of the distribution of identified distresses across the structure. The heat map generated using the kernel density tool provided valuable insights, particularly regarding areas with a higher concentration of distress. These areas were then prioritized for further investigation to understand the potential causes of water ingress and their impact on the overall structural integrity. The analysis is done in two parts: first for analysis of Mangalore tiles, and then second is the analysis of the pitched roof.

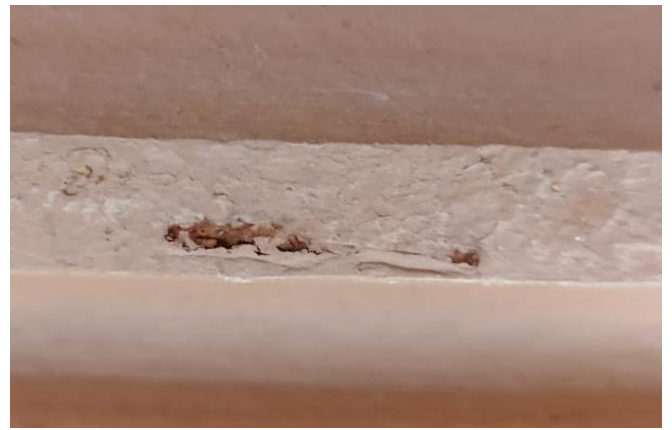
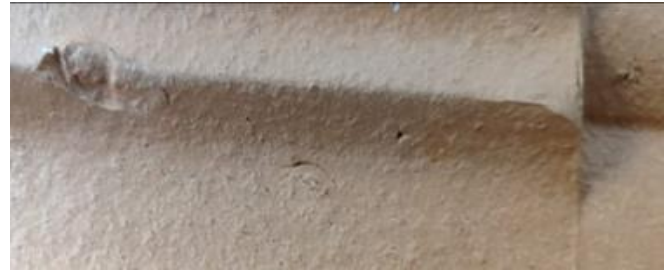
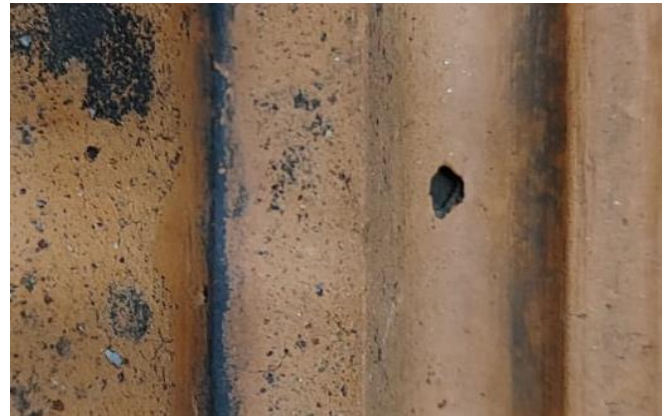
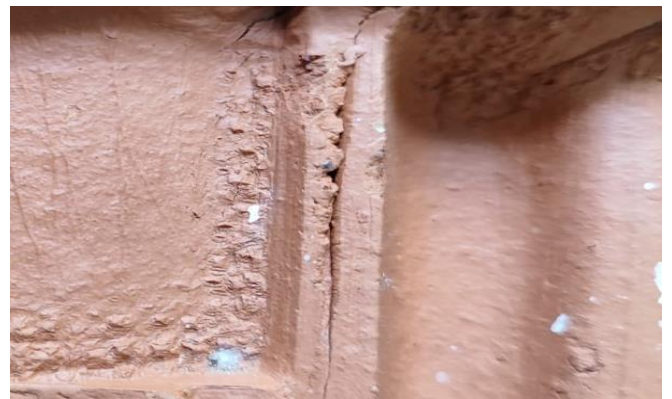
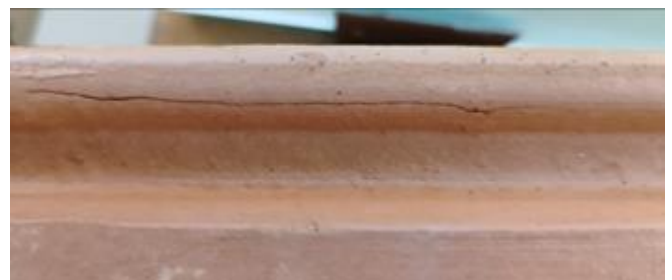
Figure 10: Distresses Present in Mangalore Tile

Functional deficiencies in tiles are defects that hinder their ability to protect a structure from sun and water ingress. Examples include cracks, fractures, and broken tiles.

Functional deficiencies such as cracks, fractures, broken tiles, or imperfections in the tile body can create direct pathways for water to seep through, causing damage to the structure.

While **WATER ABSORPTION** itself may NOT DIRECTLY CAUSE LEAKS, it can make tiles more vulnerable when the above-mentioned factors are present. Absorbed water can travel through cracks and contribute to leakage. Lower-quality tiles might have higher water absorption rates and be more prone to cracking.

In areas with freezing temperatures, absorbed water can freeze and expand, potentially causing cracks in the tiles and exacerbating leakage issues.

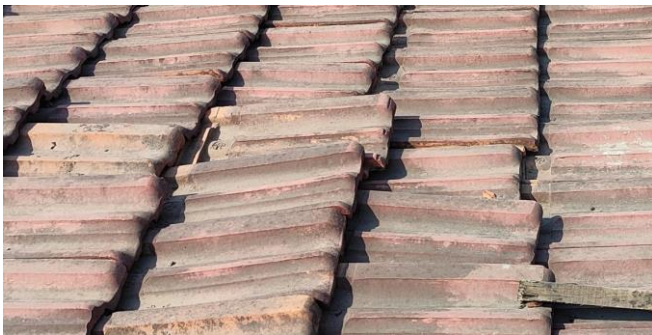
Figure 11: Misalignment of Mangalore Tile

MISALIGNMENT in pitched roofs can occur due to a variety of factors. Human or animal interventions, (particularly from monkeys), improper installation of roofing tile, strong wind or storm can put pressure on roofing material and can disrupt the alignment of roofing tiles. Additionally, uneven settlement of the supporting truss system and the foundation of the structure can also contribute to misalignment.

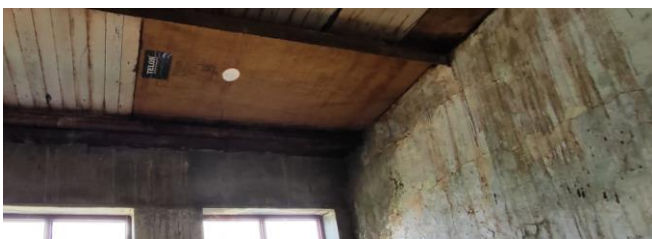
Figure 12: Failure of underlayment

UNDERLAYMENT serve as a protective layer beneath roofing materials, shielding the structure from water ingress. While underlayment offers valuable protection, they also have certain drawbacks. These materials can tear easily and become brittle when exposed to direct sunlight, leading to damage and reduced effectiveness. Additionally, underlayment can be costly. Proper installation is crucial; if not installed correctly, underlayment may fail to provide the desired level of protection.

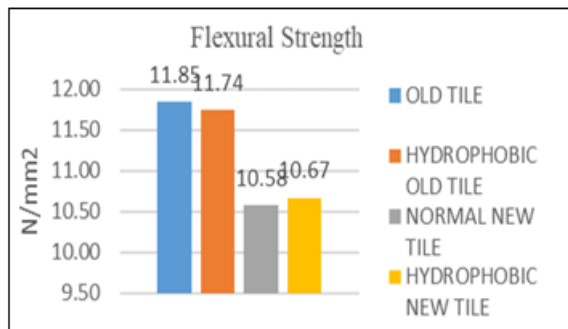
Figure 14: Flexural Strength of Tile

This study can investigate the effectiveness of water repellent on Mangalore tiles by employing a Flexural strength test to check effect of water repellent on tile. This test is crucial for assessing a tile's capacity to resist bending after application of water repellent a key factor influencing durability.

Based on the data, it is clear that the water-repellent chemical does not reduce the flexural strength of Mangalore tiles. This is a significant finding for our research, as it indicates that the chemical can be used for waterproofing pitched roof without compromising the structural integrity of the tiles.

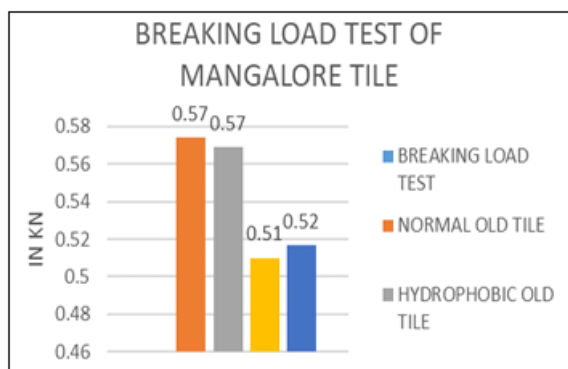
Figure 15: Breaking load of Tile

This study can investigate the effectiveness of water repellent on Mangalore tiles by employing a Breaking Load test to check effect of water repellent material on tiles property, this test is crucial for assessing a tile's ability to withstand the maximum load before breaking after application of water repellent a key factor influencing durability.

Based on the data, it is clear that the water-repellent chemical does not reduce the breaking load of Mangalore tiles. This is a significant finding for our research, as it indicates that the chemical can be used for waterproofing pitched roof without compromising the structural integrity of the tiles.

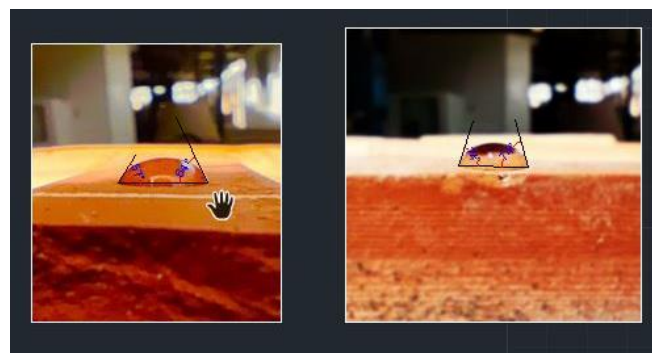
Figure 16: Contact angle of uncoated Tile

This study can assess the effectiveness of water repellents on Mangalore tiles using a contact angle test. This test measures a tile's hydrophobicity, or its ability to repel water. Higher contact angles indicate a more effective treatment.

Tile	Sample	Left Angle	Right Angle	Average Angle
1	1	52	48	50
	2	70	67	68.5
	3	63	65	64
	4	70	71	70.5
2	5	71	69	70
	6	63	60	61.5
	7	65	68	66.5
	8	73	66	69.5
3	9	73	63	68
	10	73	68	70.5
	11	73	64	68.5
	12	73	74	73.5

- 1) **Low Contact Angle (<90°):** Indicates high wettability. The liquid spreads out on the surface.
- 2) **High Contact Angle (>90°):** Indicates low wettability. The liquid forms a more spherical droplet on the surface.
