# Effective Management and Maintenance of Old Educational Infrastructure using Non-Destructive Testing and Automation in Estimation

Punit Gohil<sup>1</sup>, Dr. Sumedh Mhaske<sup>2</sup>

<sup>1</sup>Student, M. Tech Construction Management, Civil and Environmental Engineering Department, Veermata Jijabai Technological Institute (VJTI), Matunga, Mumbai, 400019, India

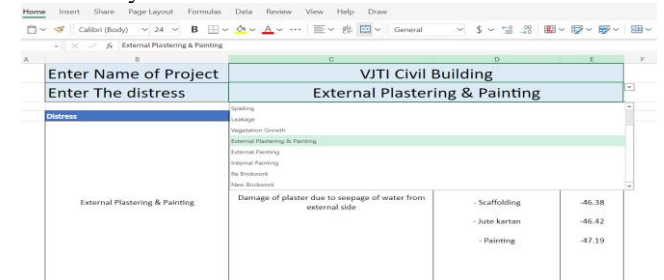
Figure 7: Frontend interface.

Frontend data means the data which user/engineer will input. The input sheet of this automated sheet is very simple to understand and has a user-friendly interface. The data sheet has predefined dropdowns which are just to be selected and then the data can be added by the user. The following data are taken by the sheet:
